On 09082020 the tug combination reached the destination and **YUVAL** was moored alongside the 'Ponton de Secours' in the Commercial Harbour.

1. Damage Description and Survey Findings

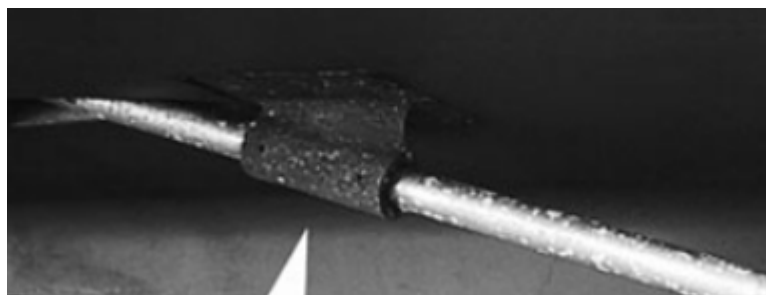
Figure 3 Intermediate Strut

The propeller shafts had a 75 mm diameter and were made of A4 grade non-magnetic stainless steel. Each one had an intermediate strut bearing and a stern strut bearing.

The intermediate strut bearings were of the I-type whilst the main were of the V-type. The latter are equipped with a grounding skeg.

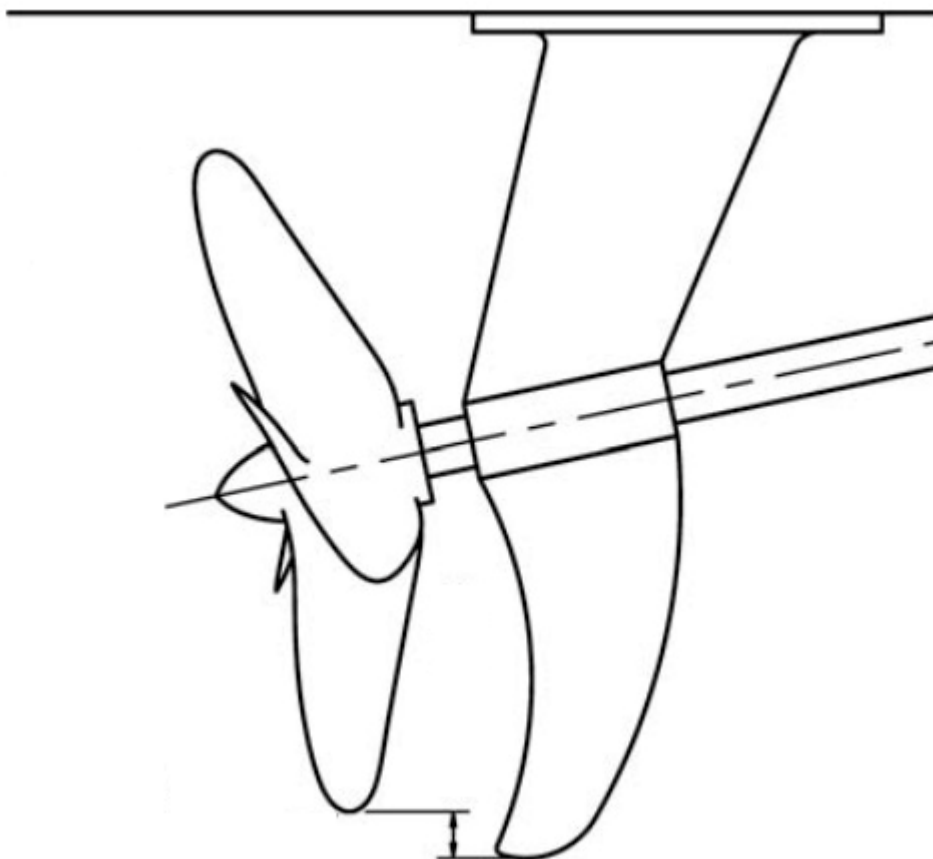
Figure 4 Grounding Skeg

All struts were of the correct length and were equipped with cutlass bearings. There was an unsupported length of 82 cm of shaft between both struts.

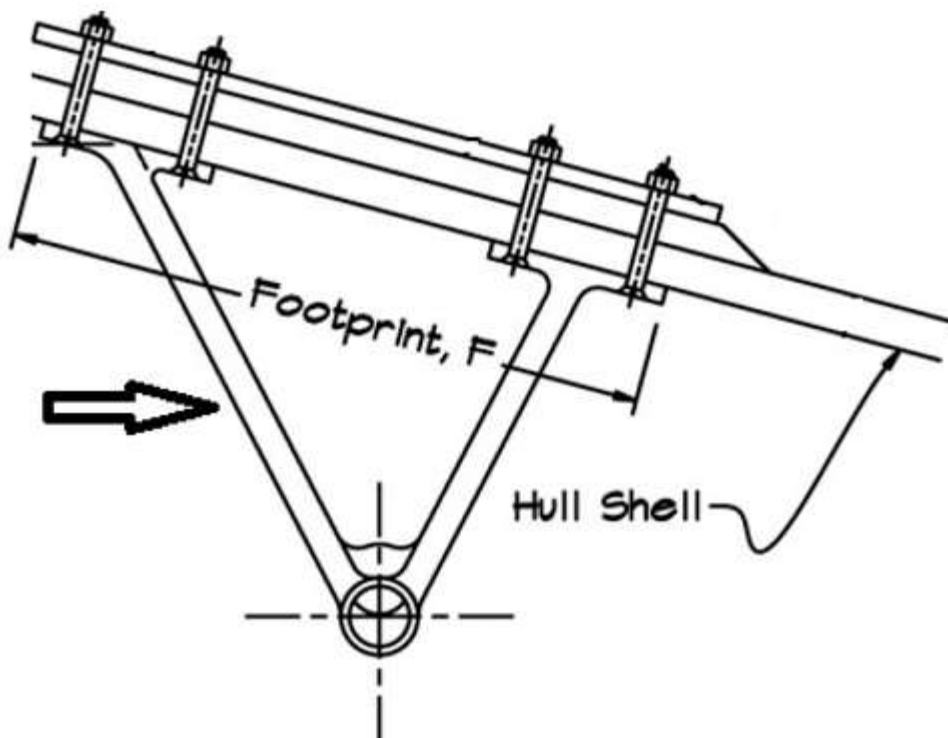
Figure 5 Misalignment

A slight bending of the shaft between both struts was measured to be 0.5 cm.

A distance of 2 mm in the vertical plane was measured between the shaft and the inner cutlass bearing of the stern strut.

A misalignment was found to exist between both struts due to bending of the longest support of the aft strut (strut grounding skeg not shown).

We were unable to get access to the inner side of the hull shell, opposite the outer footprint. Therefore, we cannot say that the aft strut port side is free from defects. As a result, factual information about the condition of the aft strut port side inside mounting is excluded from this survey report.
